# Milestone Inspection Report Phase 2

## Windsor West Condominium Association, Inc., Building B

**3704 Broadway #42**  
**Fort Myers, FL 33901**  
Prepared on:  
**3/13/2025**

## Milestone Inspection Report Phase 2

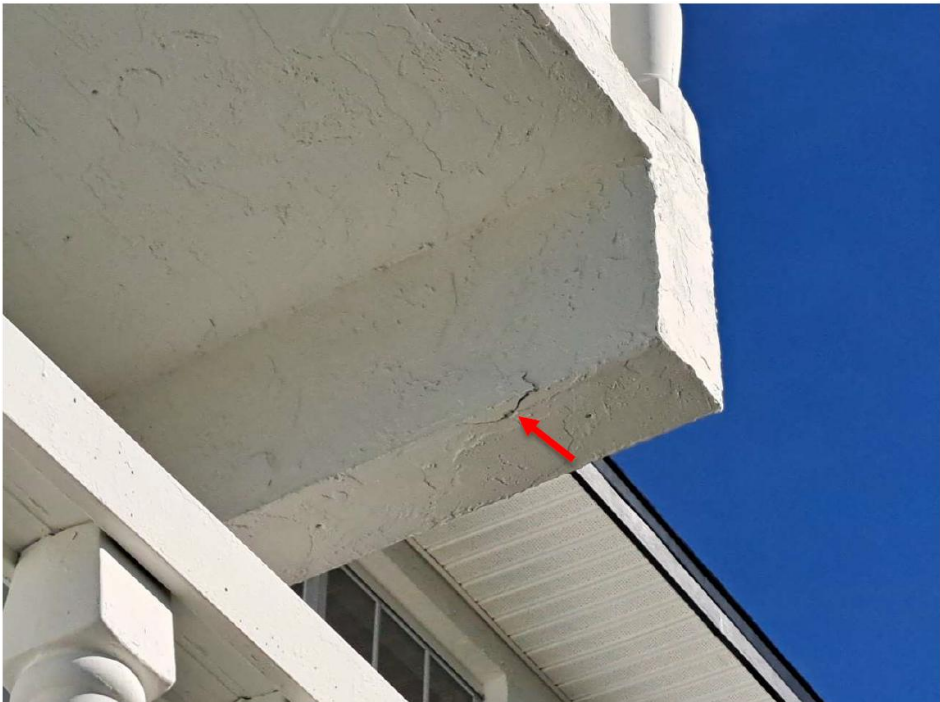
2.1.1.1 Multiple concrete spalls and cracks were observed on balcony support beams or on the balcony slabs themselves (Photos 01, 02, 03, 04, 05, 06, 07, 08 typical). Cracks and spalls in concrete become rapidly worse, especially in moist Florida air due to the carbonation process as cracks allow moisture to penetrate deeper into the concrete structure and closer to the rebar. Even openings in nonstructural items adjacent to structural items allow moisture or rain to collect in a moist environment next to the structural item. Spalls will worsen exponentially until the area and surrounding concrete is repaired. See Carbonation & the Concrete Spalling / Degradation Process (pg. 2)

*Photo 01 Ref: 2.1.1.1 – Support Beam Spall, Unit #313’s Balcony (Typical)*

2.1.1.3 These repairs are considered “structural” repairs and must be performed by a licensed General Contractor working under a permit issued by the municipality. The contractor shall commence repairs within 365 days of the submittal of this Phase 2 report. Concrete repairs should be completed per ICRI (International Concrete Repair Institute) and ACI (American Concrete Institute) standards following the specifications and details prepared by a Florida Registered licensed professional engineer specializing in structural restoration and strengthening of existing structures.

2.1.1.5 All damaged and loose concrete in the above-mentioned spalls should be removed while being observed by the engineer so that if additional concrete removal is required, the engineer can provide engineering direction as needed.

2.1.1.6 The engineer shall inspect the final excavation of the concrete and condition of the rebar, before any subsequent steps are taken.

2.1.1.7 The engineer shall perform a final inspection of the repair area after the repair mortar is placed.

2.1.1.8 The patch should be textured and painted to match the surrounding area.

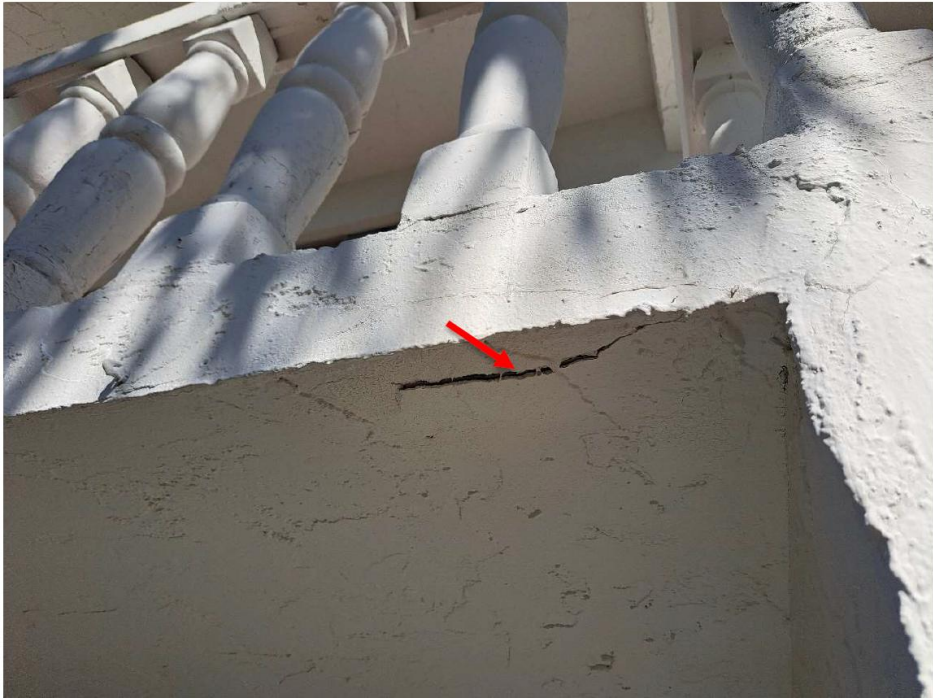
*Photo 02 Ref: 2.1.1.1 – Slab Edge Spall, Unit #209’s Balcony (Typical)*

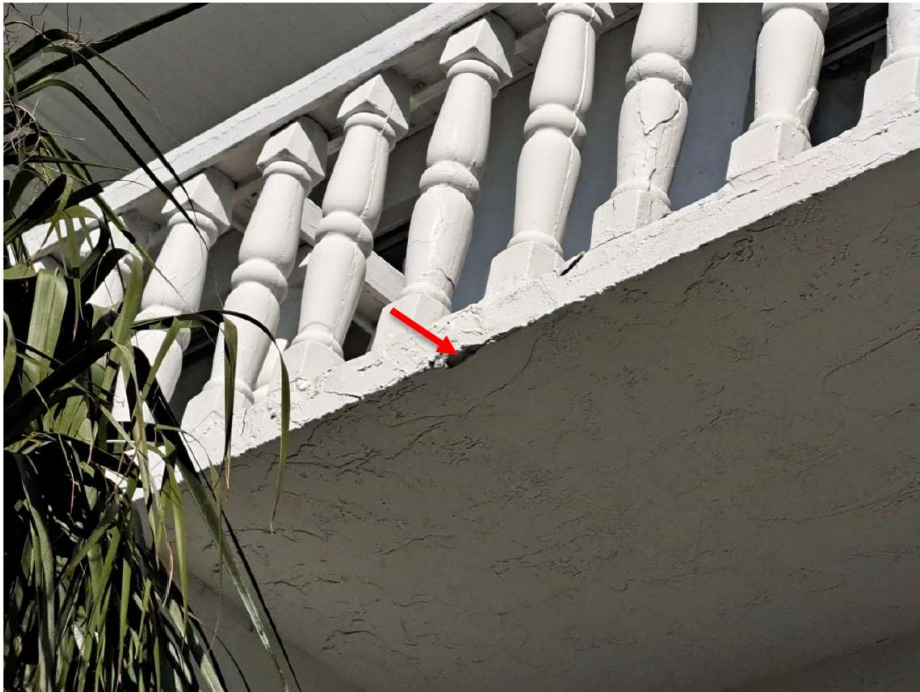
*Photo 03 Ref: 2.1.1.1 – Slab Edge Spall, Unit #307's Balcony (Typical)*

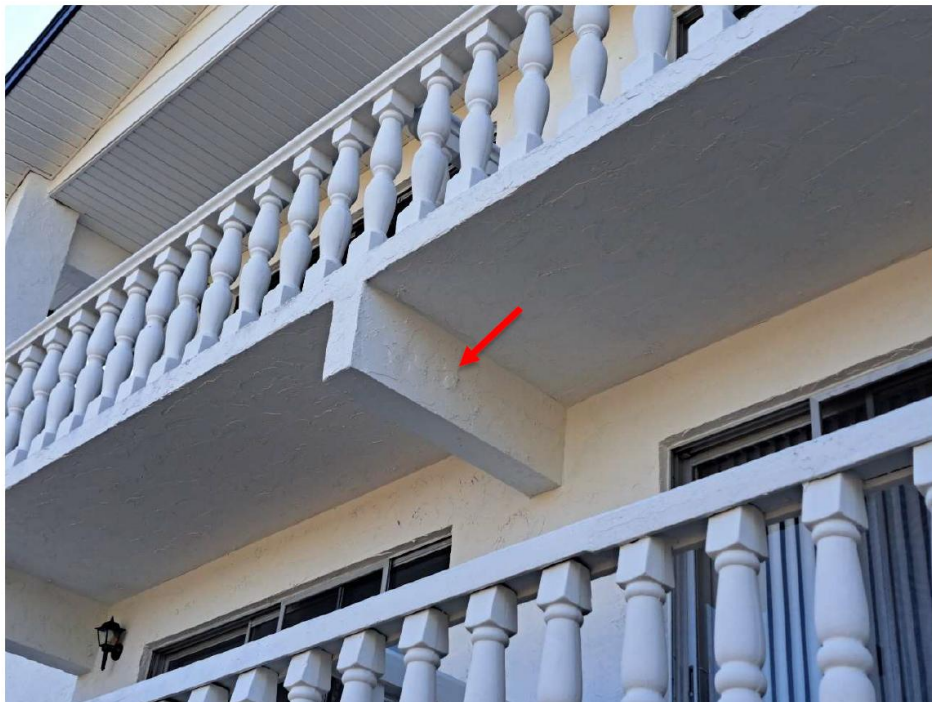
*Photo 04 Ref: 2.1.1.1 – Support Beam Spall, Unit #304's Balcony (Typical)*

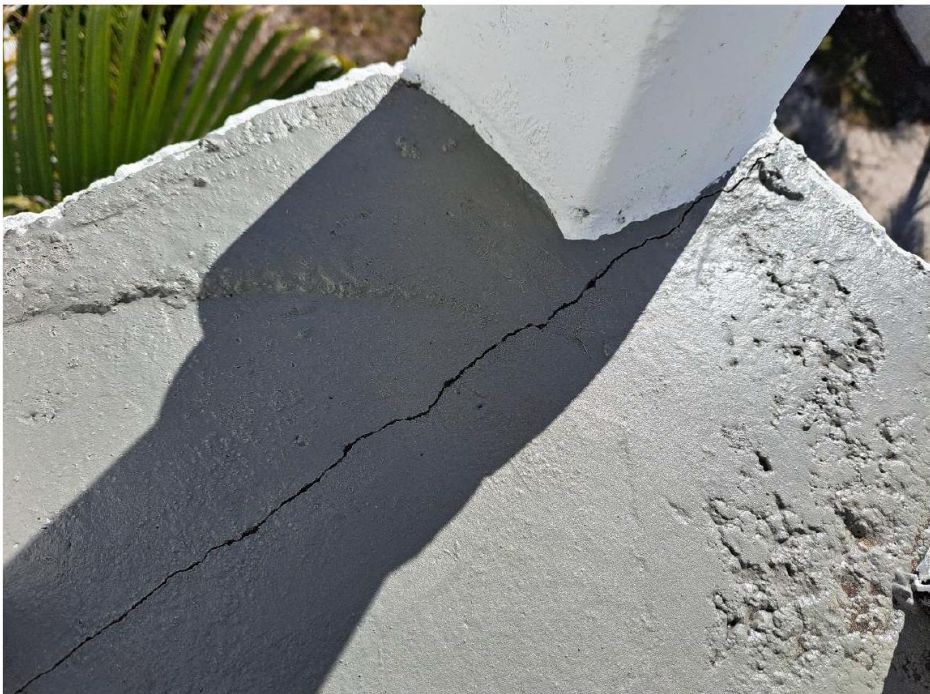
*Photo 05 Ref: 2.1.1.1 – Cracked Slab, Unit #301's Balcony (Typical)*

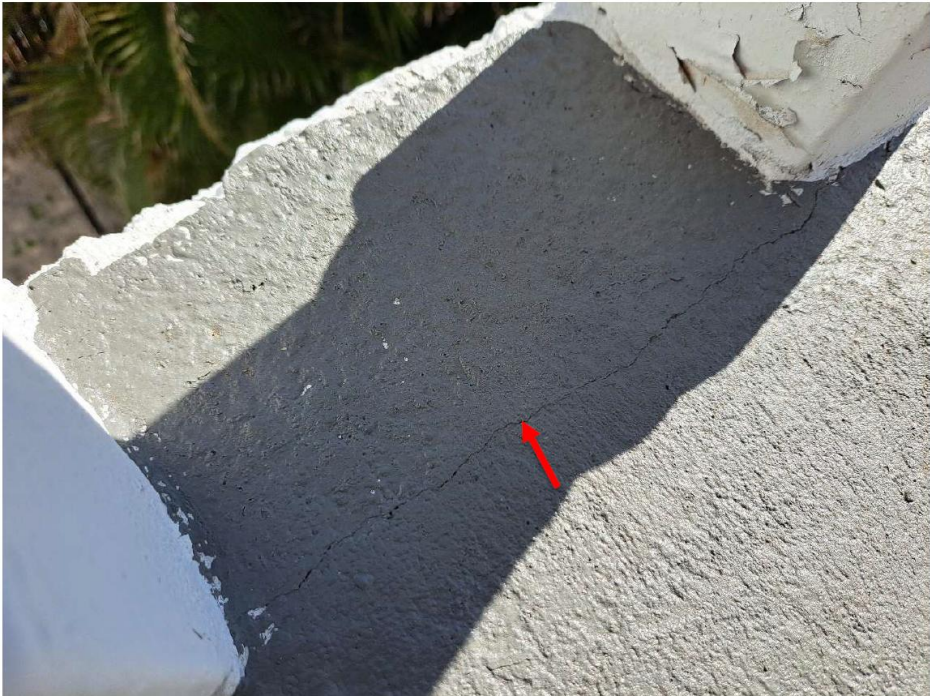
*Photo 06 Ref: 2.1.1.1 – Cracked Slab, Unit #321's Balcony (Typical)*

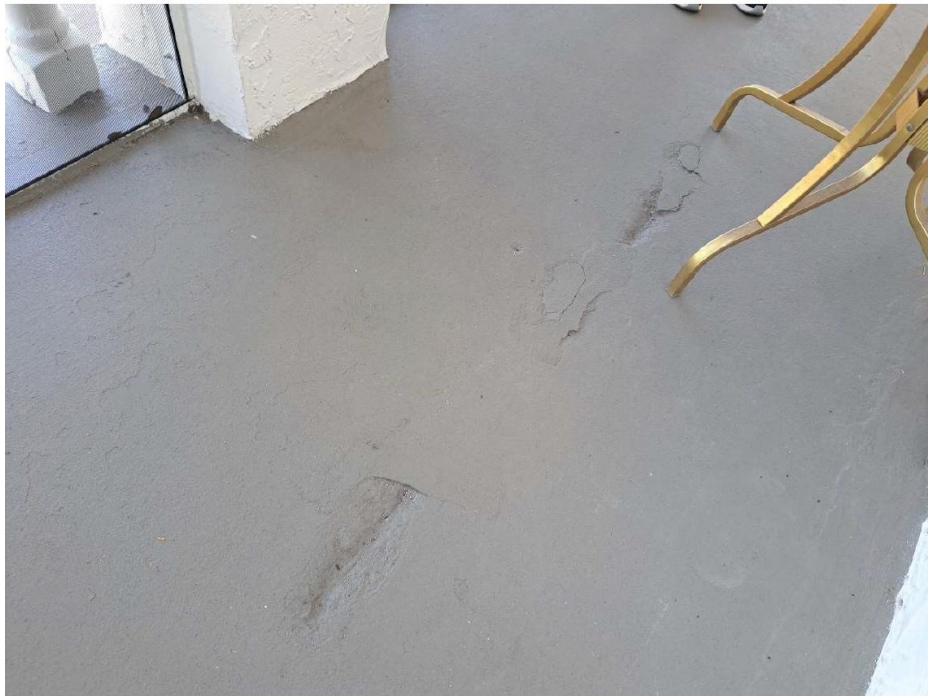
*Photo 07 Ref: 2.1.1.1 – Spalled Slab w/ Exposed Rebar, Common Room Balcony*

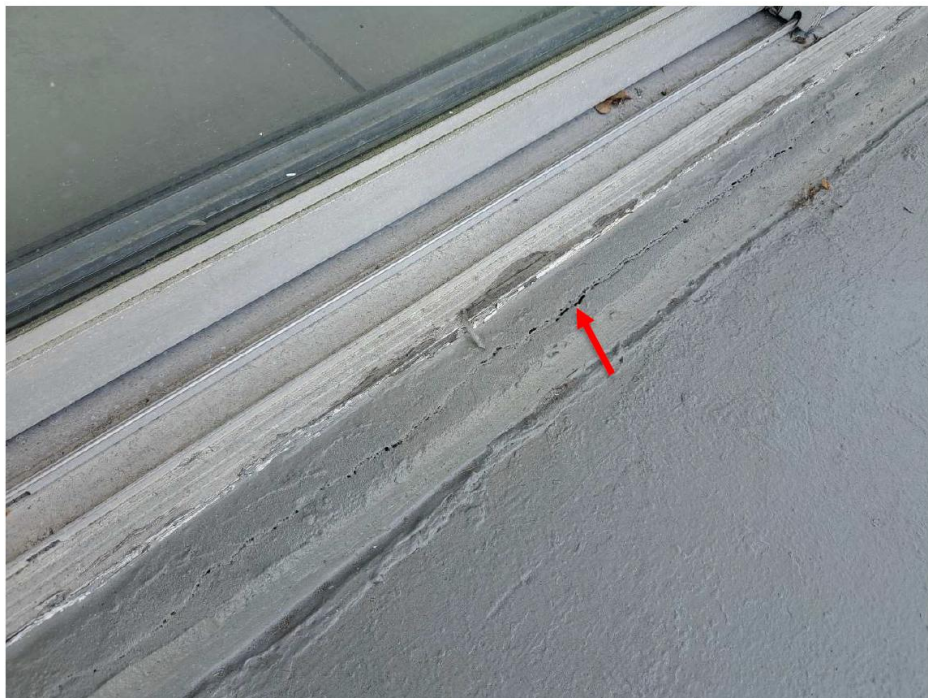
*Photo 08 Ref: 2.1.1.1 – Spalled Door Sill, Unit #320's Balcony (Typical)*

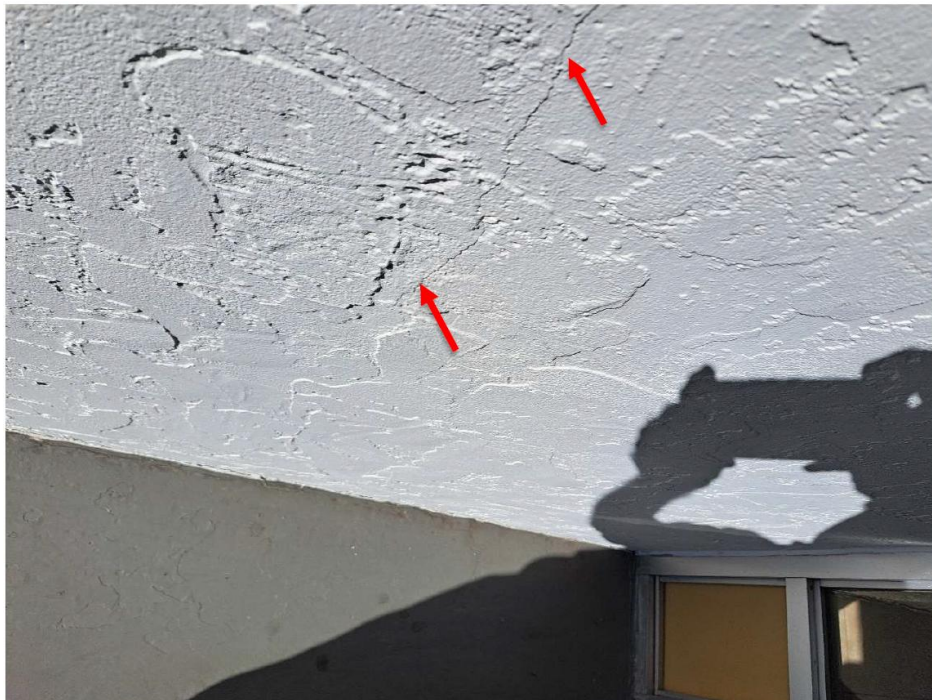
- 2.1.2.1 Cracks and spalls were observed on the exterior concrete walls (Photos 09, 10, 11 typical). This damage should be repaired properly to prevent further damage to the concrete supporting walls. As moisture and rain enter these openings in the stucco or concrete, or as the incorrectly repaired spalls worsen; the damage will expand exponentially.

*Photo 09 Ref: 2.1.2.1 – Crack In Entrance Wall, Pool Side*

- 2.1.2.2 Instructions For Repair:
- 2.1.2.3 These repairs are considered “structural” repairs and must be performed by a licensed General Contractor working under a permit issued by the municipality. The contractor shall commence repairs within 365 days of the submittal of this Phase 2 report. Concrete repairs should be completed per ICRI (International Concrete Repair Institute) and ACI (American Concrete Institute) standards following the specifications and details prepared by a Florida Registered licensed professional engineer specializing in structural restoration and strengthening of existing structures.

- 2.1.2.4 The Association shall secure the services of a Florida Registered licensed professional engineer.
- 2.1.2.5 All damaged and loose concrete in the above-mentioned spalls should be removed while being observed by the engineer so that if additional concrete removal is required, the engineer can provide engineering direction as needed.

- 2.1.2.6 The engineer shall inspect the final excavation of the concrete and condition of the rebar, before any subsequent steps are taken.
- 2.1.2.7 The engineer shall perform a final inspection of the repair area after the repair mortar is placed.

- 2.1.2.8 The patch should be textured and painted to match the surrounding area.

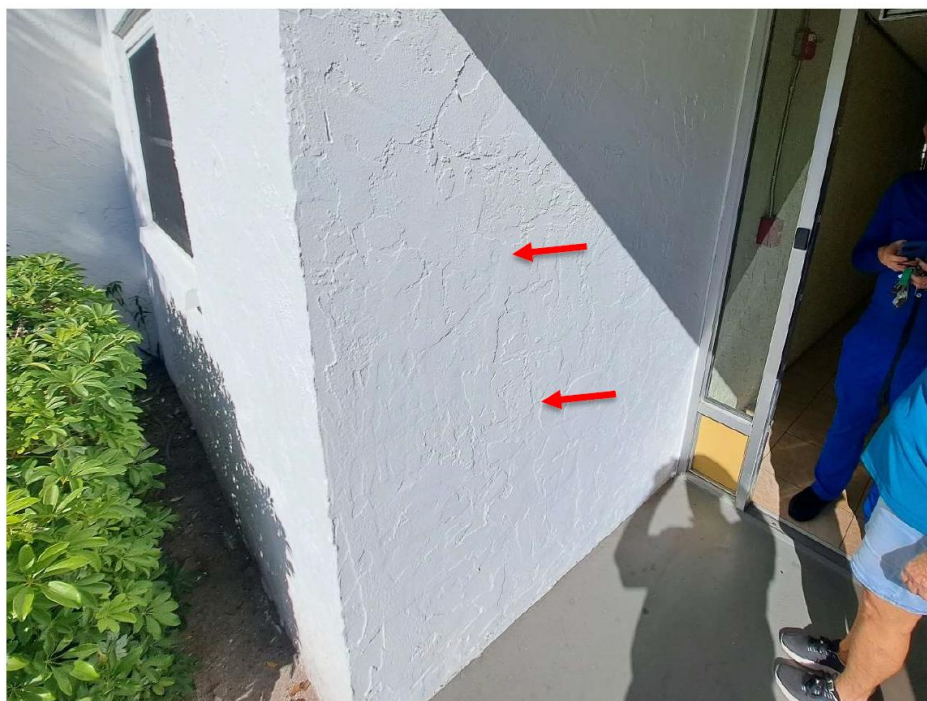
*Photo 10 Ref: 2.1.2.1 – Crack In Entrance Wall, Pool Side*

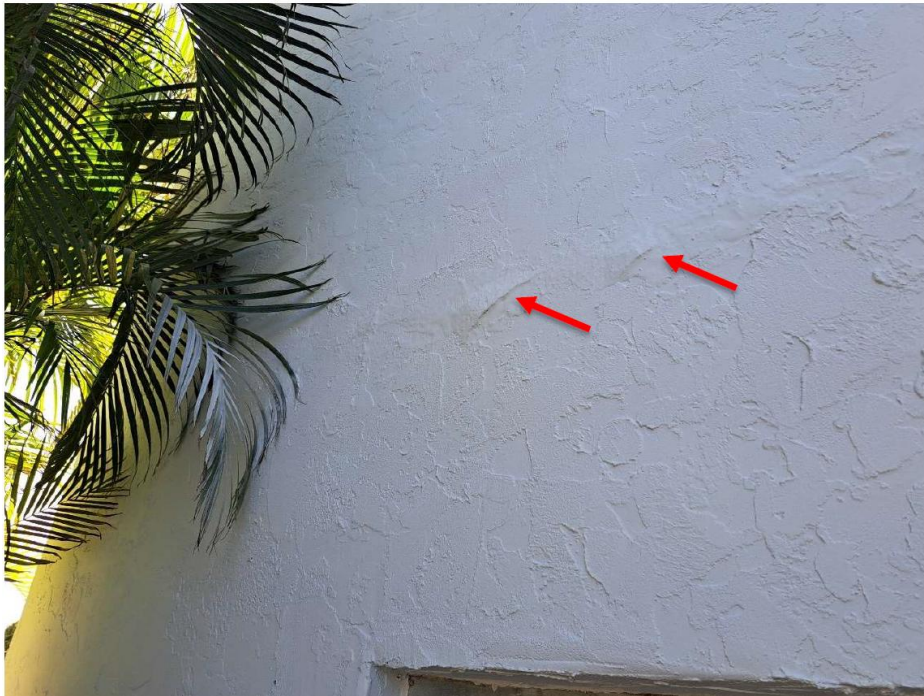
*Photo 11 Ref: 2.1.2.1 – Spall On Exterior Wall, Parking Side (Typical)*

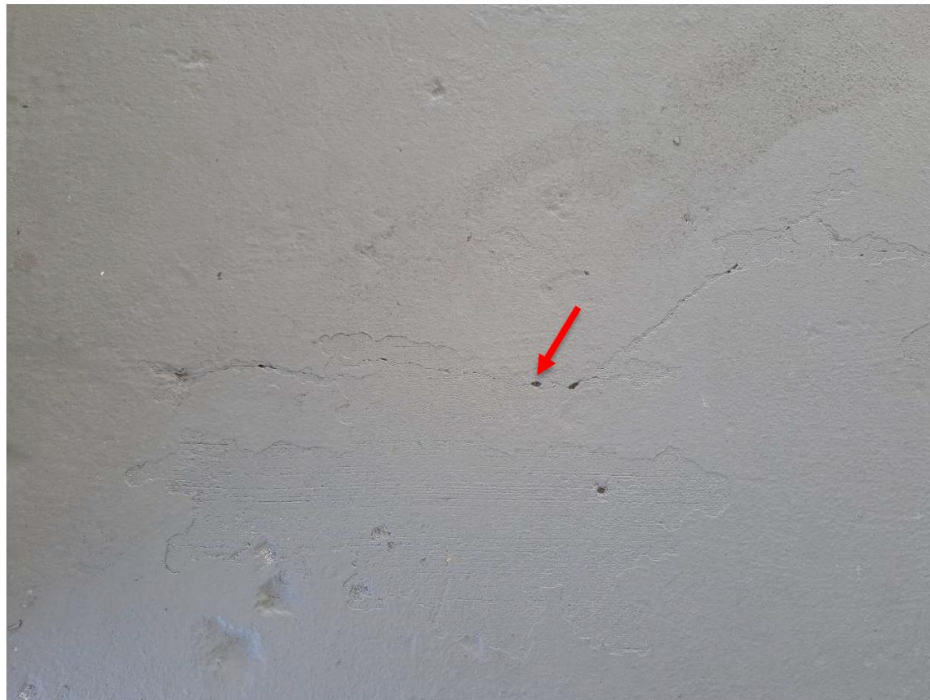
2.1.3.1 Multiple concrete spalls and cracks were observed on stair tower slabs (Photos 12, 13, 14, 15, 16, 17, 18, 19, 20, 21, 22, 23 typical). We also observed a compromised seam between a stair tower floor slab and a masonry wall adjacent to and below it (Photos 15, 16). The seam will hold rain runoff and degrade the wall below as well as the slab edge above. Cracks and concrete damage become rapidly worse, especially in moist Florida air due to the carbonation process as cracks allow moisture to penetrate deeper into the concrete structure and closer to the rebar. See Carbonation & the Concrete Spalling / Degradation Process (pg. 2)

*Photo 12 Ref: 2.1.3.1 – Crack In Stair Landing Floor Slab, , East Tower (Typical)*

2.1.3.3 These repairs are considered “structural” repairs and must be performed by a licensed General Contractor working under a permit issued by the municipality. The contractor shall commence repairs within 365 days of the submittal of this Phase 2 report. Concrete repairs should be completed per ICRI (International Concrete Repair Institute) and ACI (American Concrete Institute) standards following the specifications and details prepared by a Florida Registered licensed professional engineer specializing in structural restoration and strengthening of existing structures.

- 2.1.3.4 The Association shall secure the services of a Florida Registered licensed professional engineer.
- 2.1.3.5 All damaged and loose concrete in the above-mentioned spalls should be removed while being observed by the engineer so that if additional concrete removal is required, the engineer can provide engineering direction as needed.
- 2.1.3.6 The engineer shall inspect the final excavation of the concrete and condition of the rebar, before any subsequent steps are taken.
- 2.1.3.7 The engineer shall perform a final inspection of the repair area after the repair mortar is placed.
- 2.1.3.8 The patch should be textured and painted to match the surrounding area.

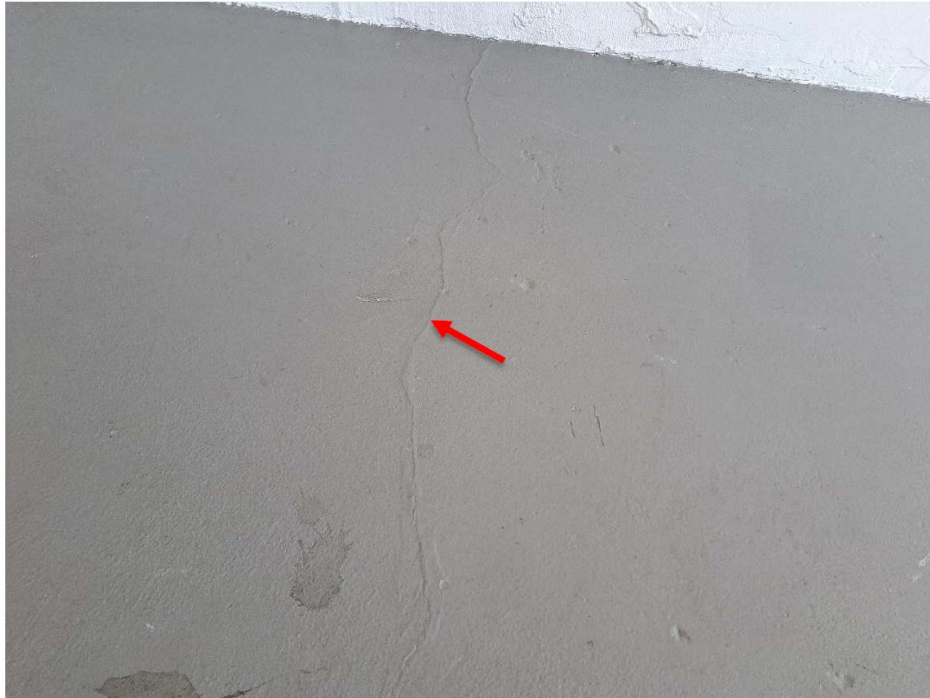
*Photo 13 Ref: 2.1.3.1 – Crack In Stair Landing Floor Slab, , East Tower (Typical)*

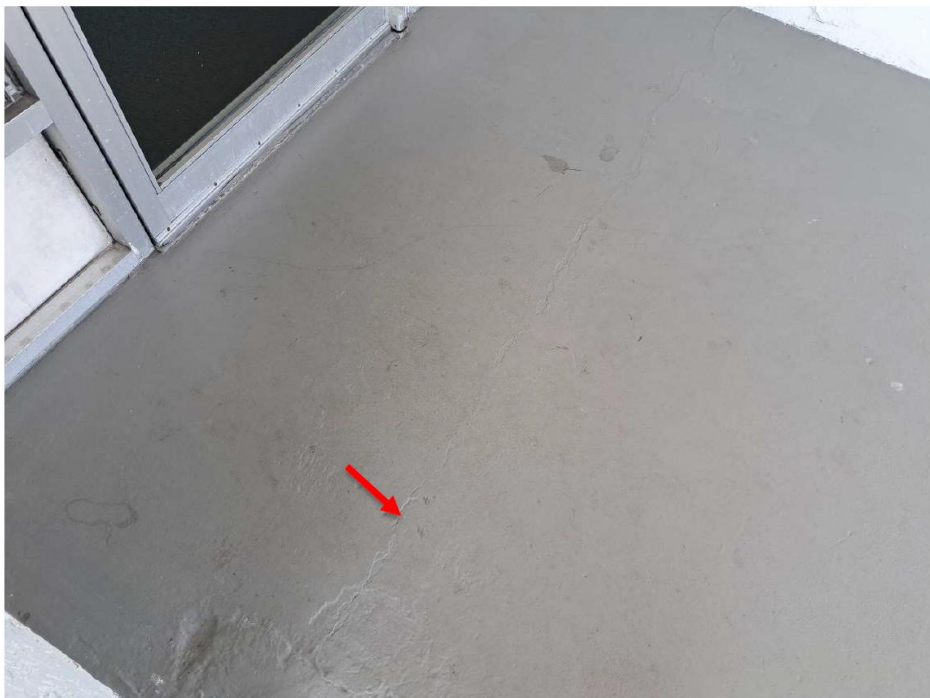
*Photo 14 Ref: 2.1.3.1 – Crack In Stair Landing Floor Slab, , East Tower (Typical)*

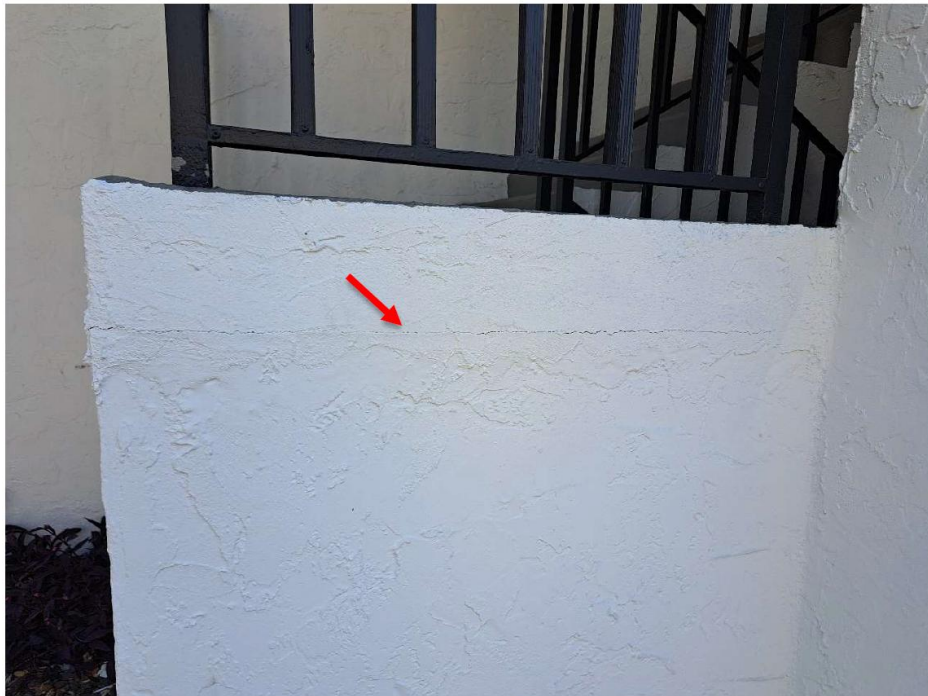
*Photo 15 Ref: 2.1.3.1 – Crack Between Stair Landing Floor Slab & Wall, , West Tower*

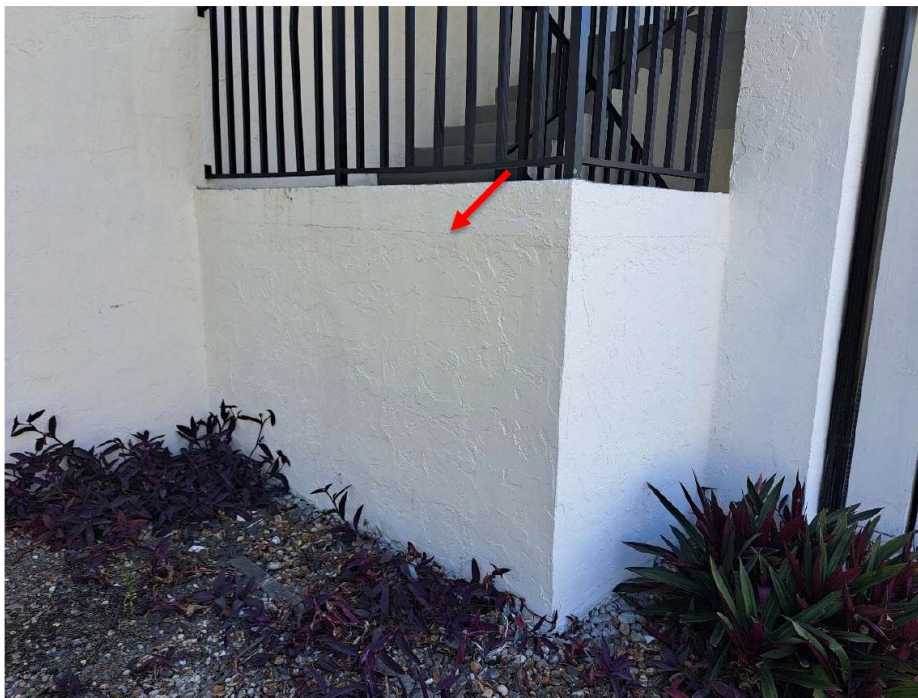
*Photo 16 Ref: 2.1.3.1 – Crack Between Stair Landing Floor Slab & Wall, , West Tower*

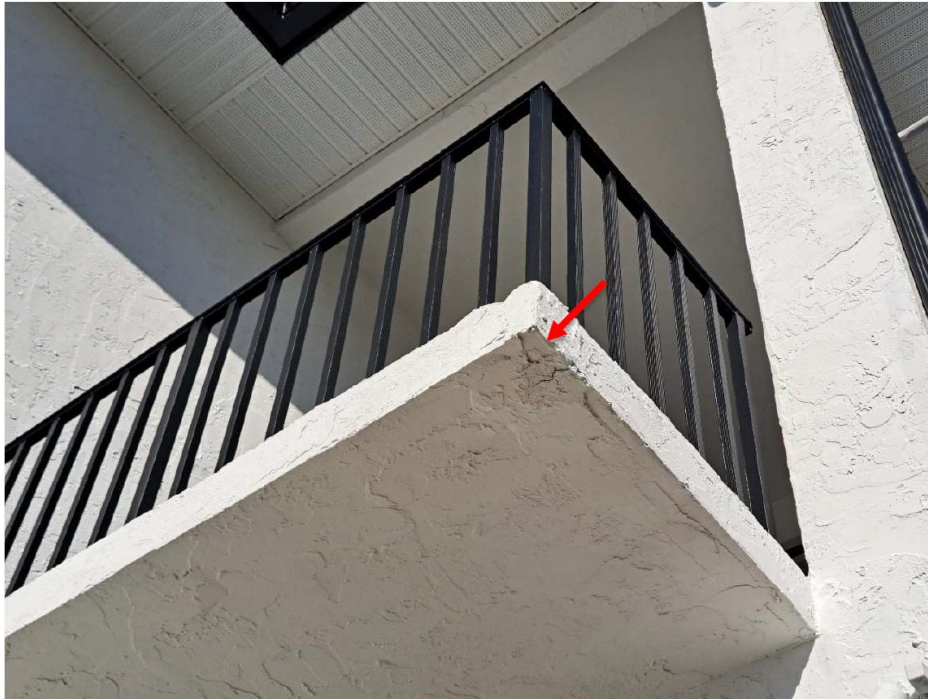
*Photo 17 Ref: 2.1.3.1 – Spalled Stair Landing, East Tower*

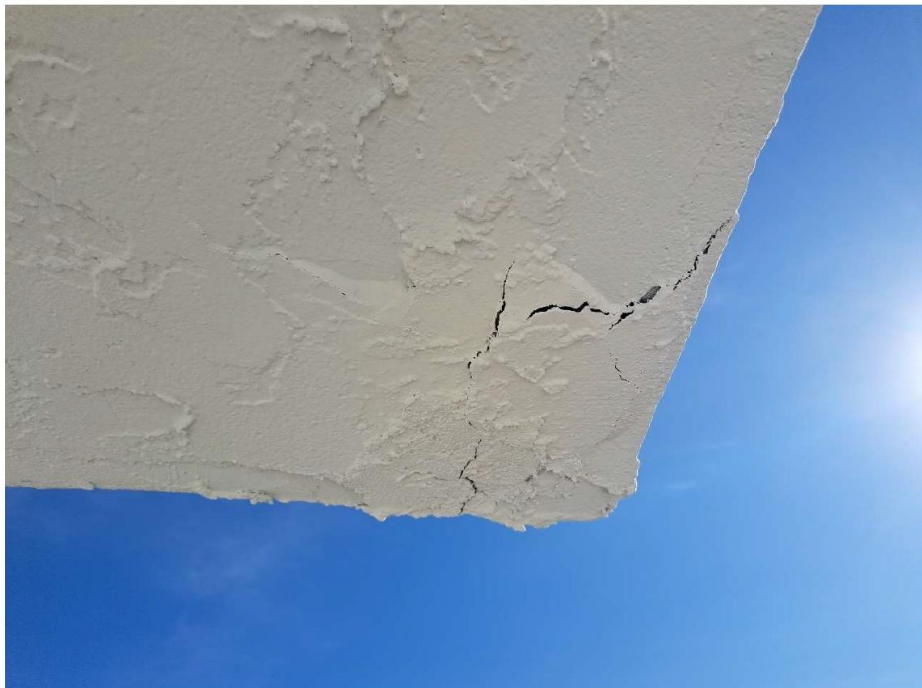
*Photo 18 Ref: 2.1.3.1 – Spalled Stair Landing, East Tower*

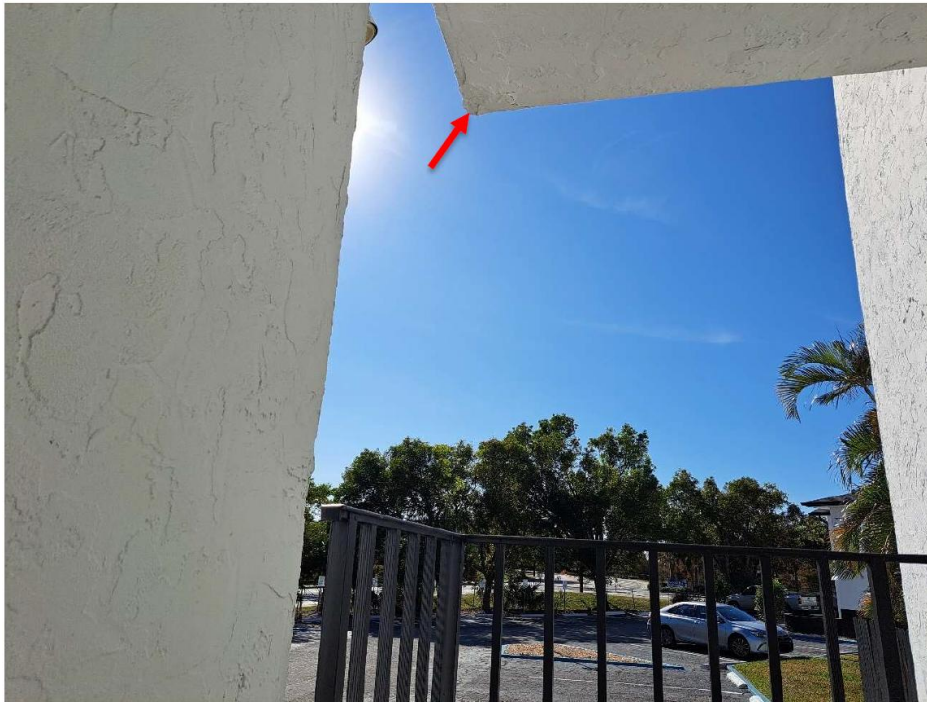
*Photo 19 Ref: 2.1.3.1 – Spalled Stair Landing, East Tower*

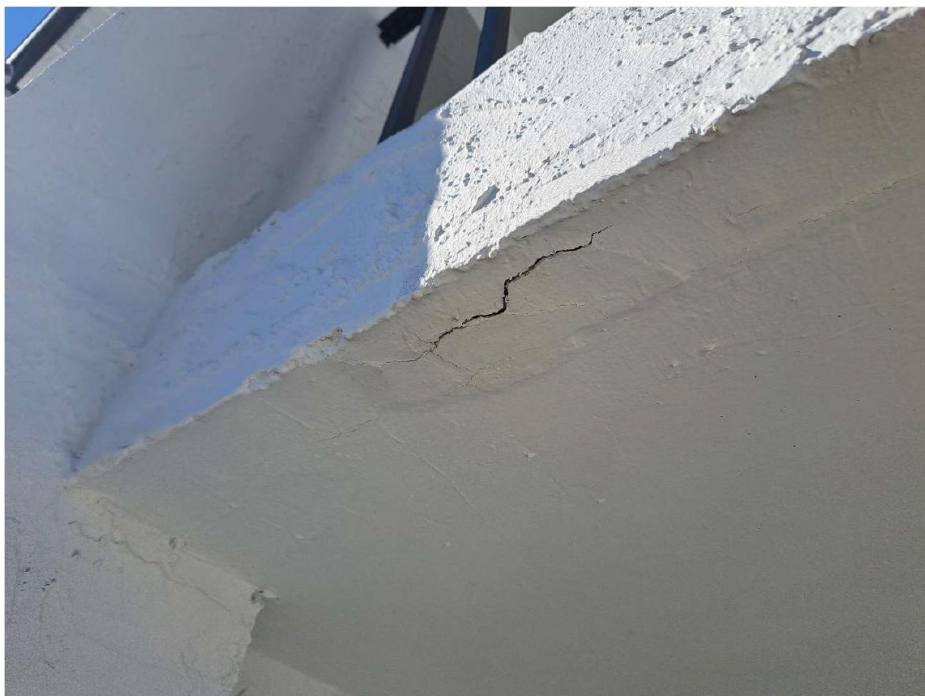
*Photo 20 Ref: 2.1.3.1 – Spalled Stair Landing, East Tower*

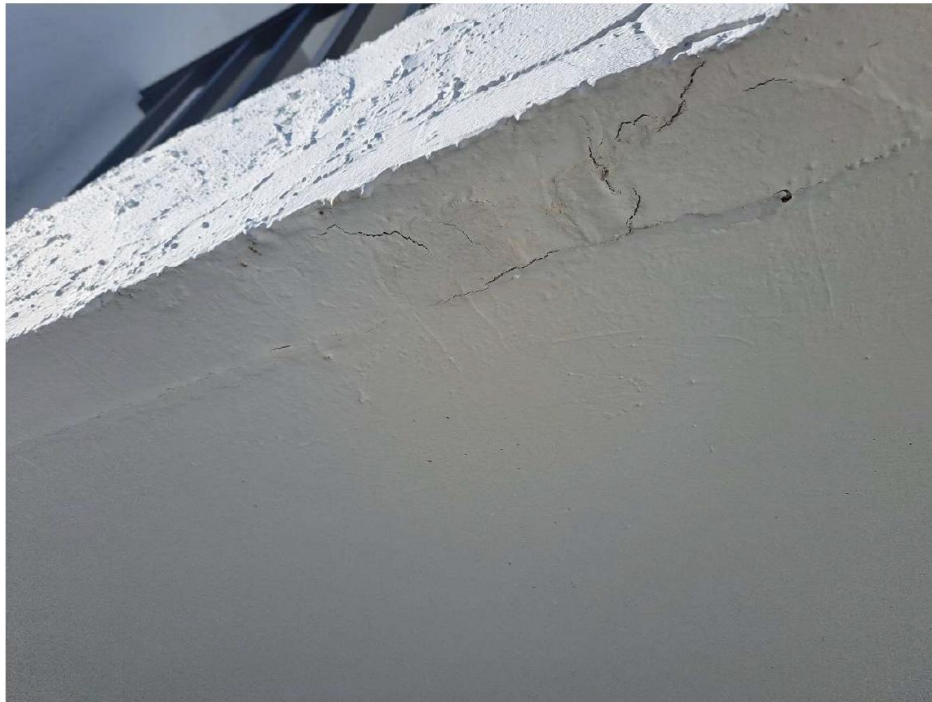
*Photo 21 Ref: 2.1.3.1 – Spalled Stair Landing, East Tower*

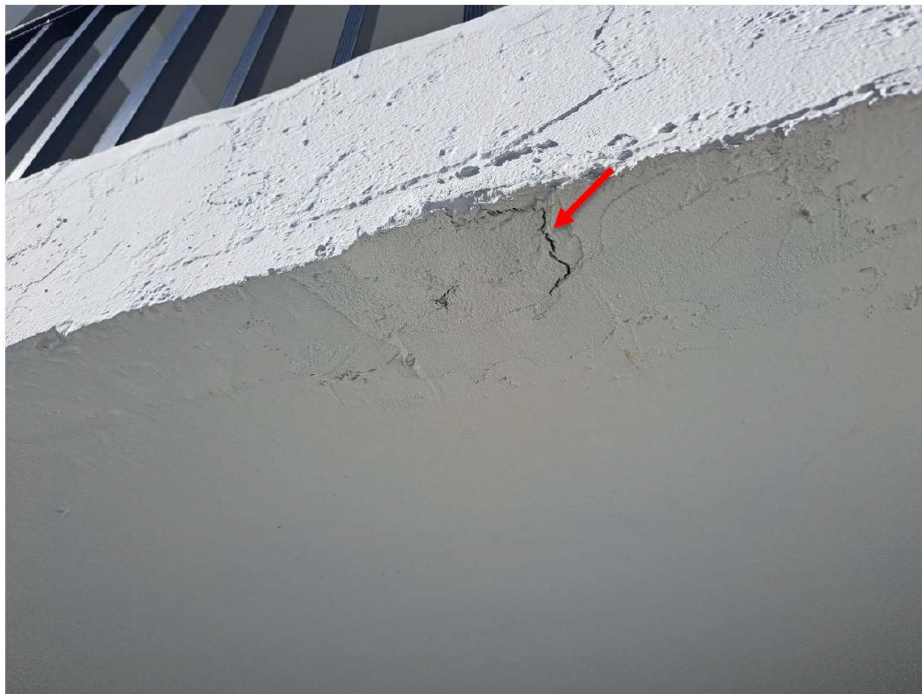
*Photo 22 Ref: 2.1.3.1 – Spalled Stair Landing, East Tower*

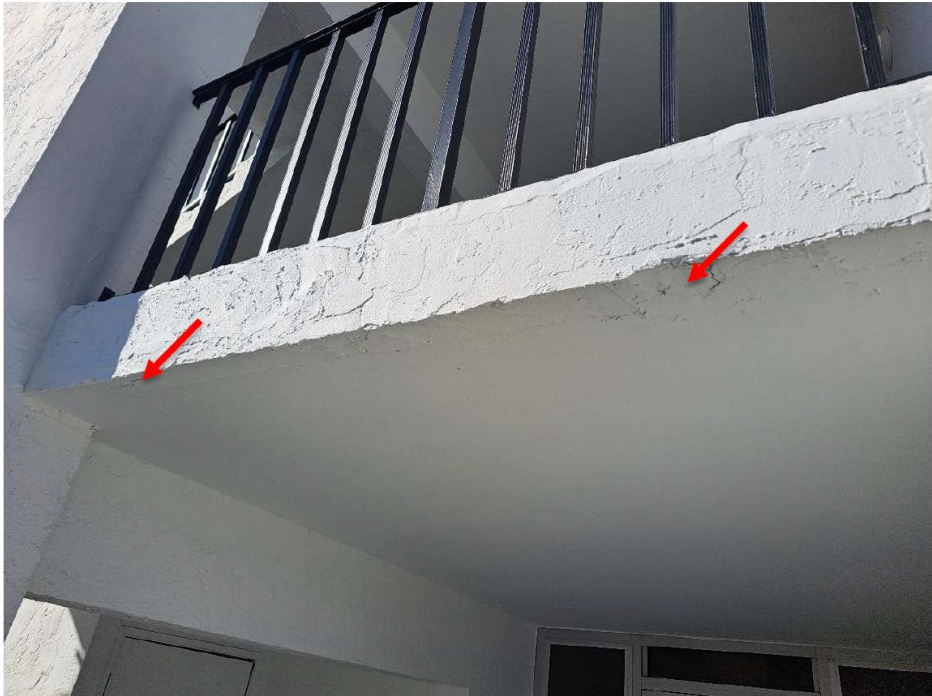
*Photo 23 Ref: 2.1.3.1 – Spalled Stair Landing, East Tower*
