Job #44247867

POOL/SPA REPORT

American Leak Detection of Southwest Florida

Windsor West - POOL

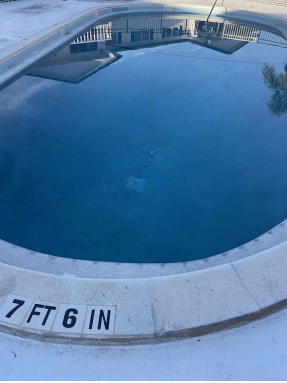
<p>Special Features Are there any special features? <input checked="" type="checkbox"/> Not Applicable</p>	<p>Pool Structure The pool structure is made of: Concrete</p>
<p>Pool Finish The pool and or spa finish is made of: Diamond Brite</p>	<p>Water Condition Is the pool/spa full, clean and clear? Yes</p>
<p>Photo of Pool/Spa</p>

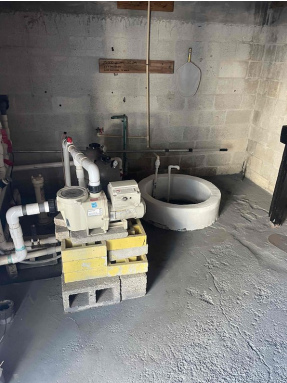
<p>Condition of Pump Equipment The pump and related equipment were found to be in good working order and without leaks? Yes</p>	<p>Surge Tank Does the pool/spa have a surge tank? Yes</p>
<p>Valve Type in Surge Tank Plunger</p>	<p>Surge Tank Photo Photo of Surge Tank</p>
<p>Valve Condition The valves were found to be in good working order and without leaks? Yes</p>	<p>Pool Heater Is the pool able to be heated? Yes</p>
<p>Photo of Pump Equipment</p>
